American Samoa Community College Community and Natural Resources

# Electrical Conductivity and Major Cation Concentrations in Municipal Water from Tutuila Island, American Samoa

#### Abstract

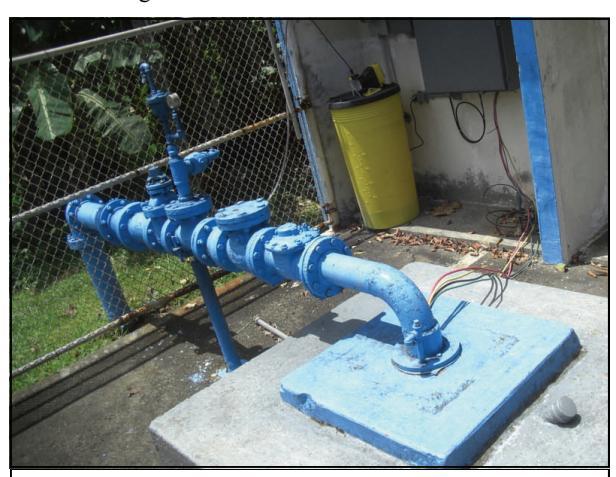
**Figure 1.** One of ASPA's 53 ground water wells. Wells are encased in concrete and may be as deep as 300 ft (90 m), requiring pumps of 30 to 40 hp (22 to 30 kW) to draw water to the surface. A 6% solution of sodium hypochlorite in the yellow drum is injected into the distribution system to disinfect the ground water as it reaches the surface.

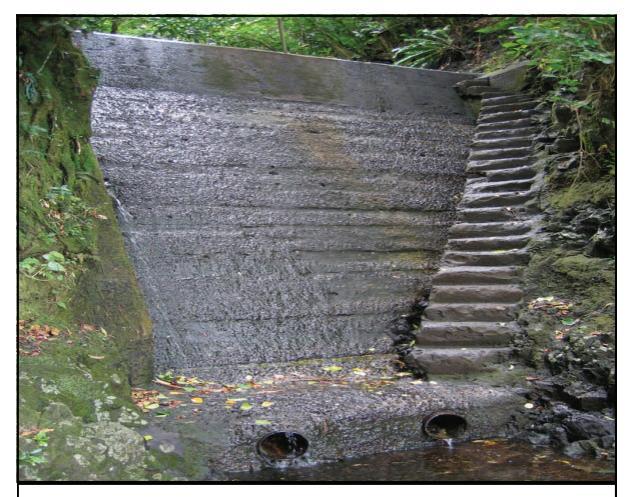
**Figure 2.** A reservoir built on a stream to supply villagers with water. These were typically built long before the municipal distribution system reached a village. Residents continue to rely upon them as a source of drinking water.

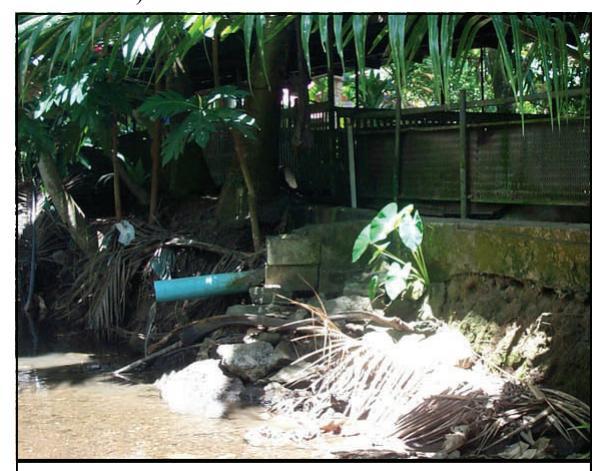
**Figure 3.** A non-compliant piggery discharging its waste directly into a stream. Prior to ASEPA's efforts to enforce the law disallowing such practices, the vast majority of piggeries were in violation. They lacked proper waste disposal systems. Most housed less than a dozen mature pigs. But some contained over a hundred pigs ranging in age and size from young piglets to breeding stock.

Widespread public outcry demanded enforcement of a law requiring piggeries to be set back at least 50 ft (15 m) from a stream or a building used for human habitation (*Samoa News*, 23 SEP 2005; Fig. 3). Despite initial opposition by some members of the Fono, ASEPA began an aggressive campaign in August and November 2006 to enforce the law. By the end of 2007, its efforts resulted in the closure of 69 non-compliant piggeries, and [with assistance from the USDA Natural Resource Conservation Service EQIP program] 57 others were able to bring their piggeries into compliance (*Samoa News*, 15 APR 2008).

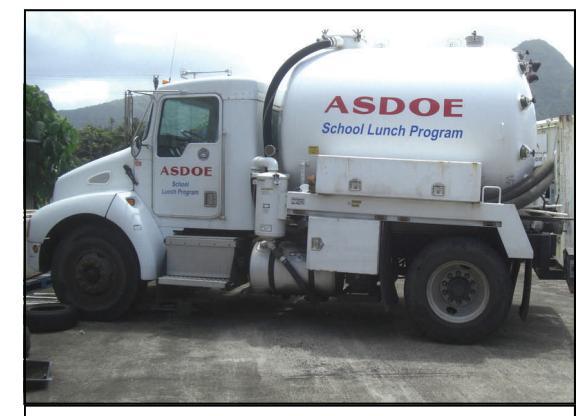
**Figure 4.** American Samoa Department of Education (ASDOE) School Lunch Program (SLP) water truck. With USDA approval, the ASDOE SLP delivers water, purified by a local bottled water vendor using reverse osmosis, to both public and private schools.

Throughout the 2010/2011 school year, ASPA provided coolers and 5-gallon (19 L) bottles for use by both private and public schools in order to ensure at least one 12-ounce (350 ml) serving of water per child per day (*Samoa News*, 04 AUG 2011). At the beginning of the 2011 school year, the American Samoa Department of Education had encouraging news that the USDA would allow the School Lunch Program of provide potable water to schools (*ibid.*; Fig. 4).

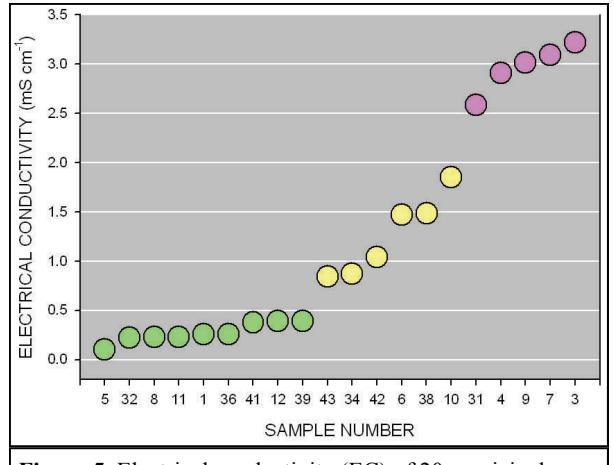
**Figure 5.** Electrical conductivity (EC) of 20 municipal water samples collected throughout Tutuila Island during 20 to 24 August, 2012. Sample numbers were arbitrarily assigned to collection bottles.

The 20 samples of tap water were divided into three classes based on their electrical conductivity (EC) levels (Fig. 5). EC is the ability of water to carry an electric current. This ability depends upon the number and type of ions dissolved in the water. EC is an indirect measure of the total dissolved solids (TDS) in water<sup>8</sup>. Therefore, TDS can easily be calculated using the formula in Fig. 6.

Samples with the lowest EC values had very little dissolved solids that could impart a taste. These were color-coded green. Samples with the highest EC values were highest in TDS. They were color-coded red. And samples whose EC values fell between these two extremes were color-coded yellow. EC and other parameters tested are given in Table 1.

A comparison of EC levels (Fig. 5) with the amount of calcium and magnesium, expressed as calcium carbonate equivalent, or CaCO<sub>3</sub>, and sodium reveals that the samples with lowest EC values had little of these cations dissolved in them (Fig. 7). For samples with medium and high EC values, the relationship between EC and cation concentration is more complex.

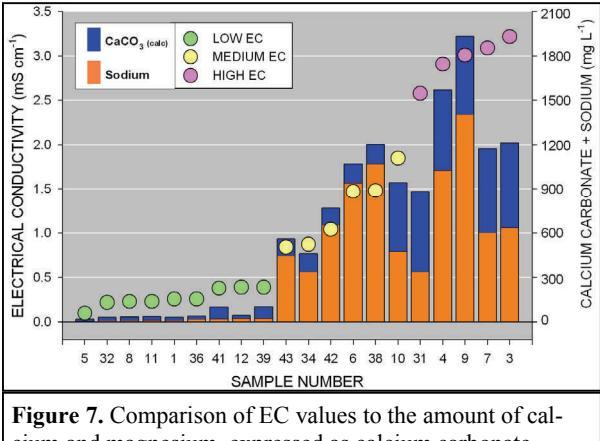
cium and magnesium, expressed as calcium carbonate equivalents, and sodium.

Samples 6 and 38, for instance, with medium EC values, have about the same level of dissolved cations are samples 7 and 3, with high EC values. They differ, though, in that the two medium EC samples have significantly more sodium cations relative to calcium carbonate equivalent, whereas the two high EC samples have about equal amounts of sodium and calcium carbonate equivalent. This near equal ratio of sodium to calcium carbonate equivalent holds for all six high EC samples. And the predominance of sodium to calcium carbonate equivalent holds for all medium EC

samples except for sample number 10. This sample shows a nearly identical sodium to calcium carbonate equivalent ratio as sample number 31, yet the latter sample's EC is significantly greater.

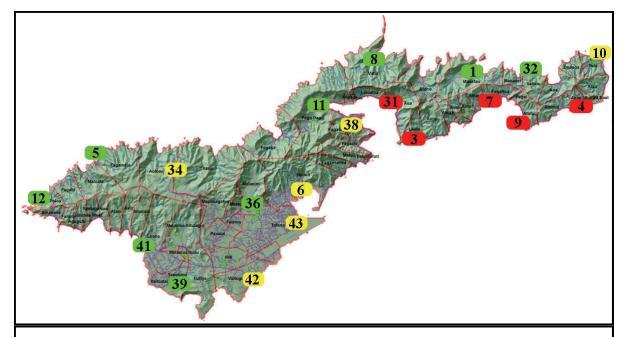
**Figure 9.** Location of tap water samples taken 20 to 24 AUG 2012 on Tutuila Island, American Samoa. Numbers and colors correspond to the sample numbers and color-codes used elsewhere in this report but the colors are intensified for clarity.

Samples with low EC values were predominantly from Western Tutuila and the north shore of Eastern Tutuila. Samples from three villages bordering Pago Harbor—Fagatogo (38), Pago Pago (11), and Aua (31)—show that their tap waters run the spectrum from low to high EC values. The EC results for tap water sampled in August 2012 were consistent with results obtained from samples collected in April 2012, with two exceptions: In April, Aoloau (34) had a low EC value while Tula (10) had a high EC value. Cation concentrations were not determined on samples collected in April. The hardness values from Table 1 may be of particular interest to consumers. All water begins as soft water falling as rain with little or not dissolved solids. As an excellent solvent, water dissolves minerals from soil and rock, making it "hard." The degree of hardness is expressed as calcium carbonate equivalents. (See the equation on p 4.) Water with a hardness value less than 17.1 mg CaCO<sub>3</sub> per liter is classified as soft (Table 2). Only one of our samples (No. 5) fell into this classification.
