ASSESSMENT OF HYDROPLANTING TECHNIQUES AND HERBICIDE  
TOLERANCE OF TWO NATIVE HAWAIIAN GROUNDCOVERS WITH  
ROADSIDE RE-VEGETATION POTENTIAL

A THESIS SUBMITTED TO THE GRADUATE DIVISION OF THE  
UNIVERSITY OF HAWAI'I IN PARTIAL FULFILLMENT  
OF THE REQUIREMENTS FOR THE DEGREE OF

MAY 2009

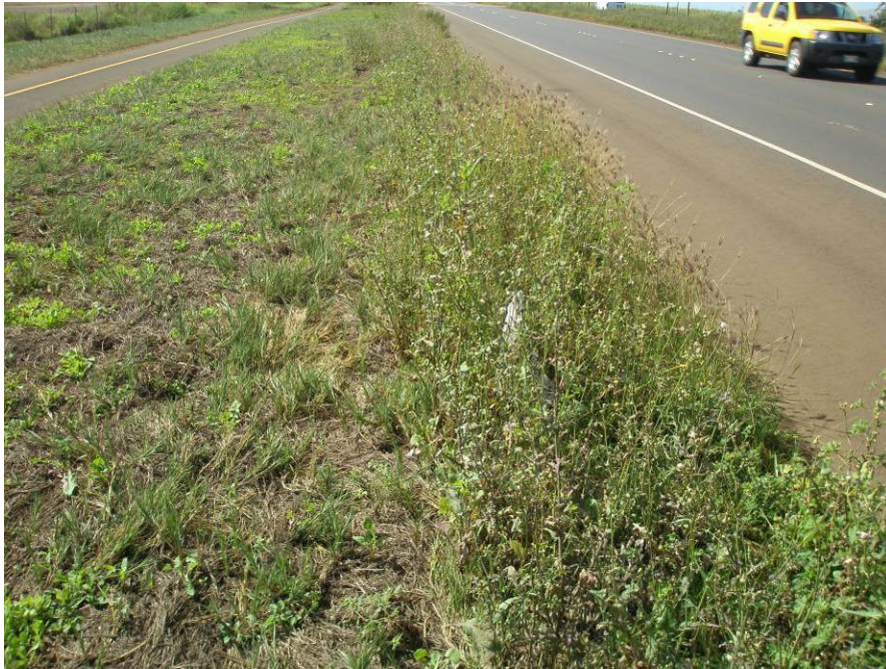
Figure 1.1. A lack of post-establishment management protocols has led to weed invasions in *Sporobolus virginicus* plantings at the Mokulele Highway, Maui.

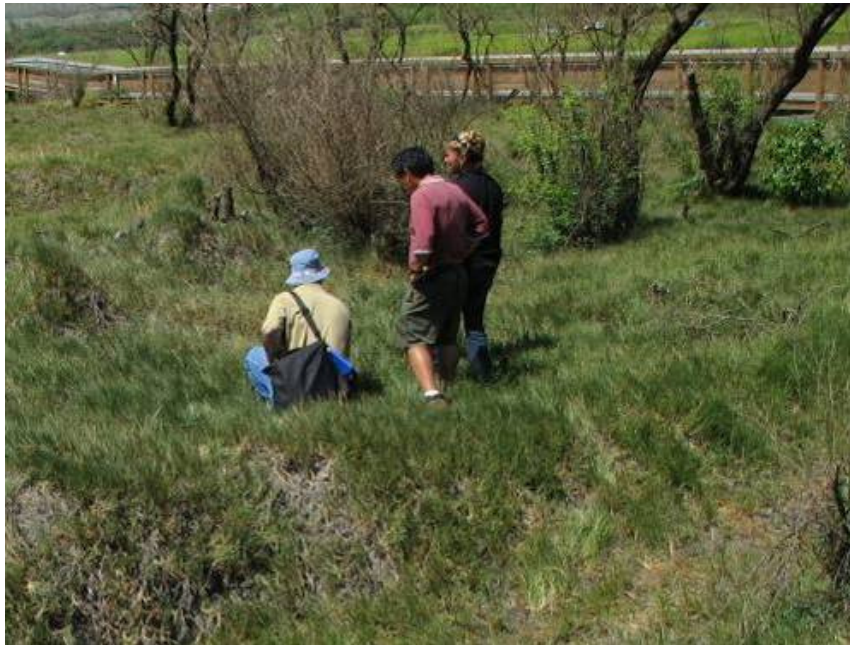
Figure 1.2. *Sporobolus virginicus* growing *in situ*. This species has formed a thick mat on sand dunes of the Kihei Coast, Maui.

*Taxonomy and distribution.* *Sporobolus virginicus* (L.) Kunth (Figure 1.2) is an indigenous perennial, rhizomatous, C<sub>4</sub> chloridoid grass with a broad distribution along tropical and subtropical shorelines (Bell and O'Leary, 2003). In Hawai'i, it is commonly found on sand dunes and coastal sites of all main islands (Wagner et al., 1999).

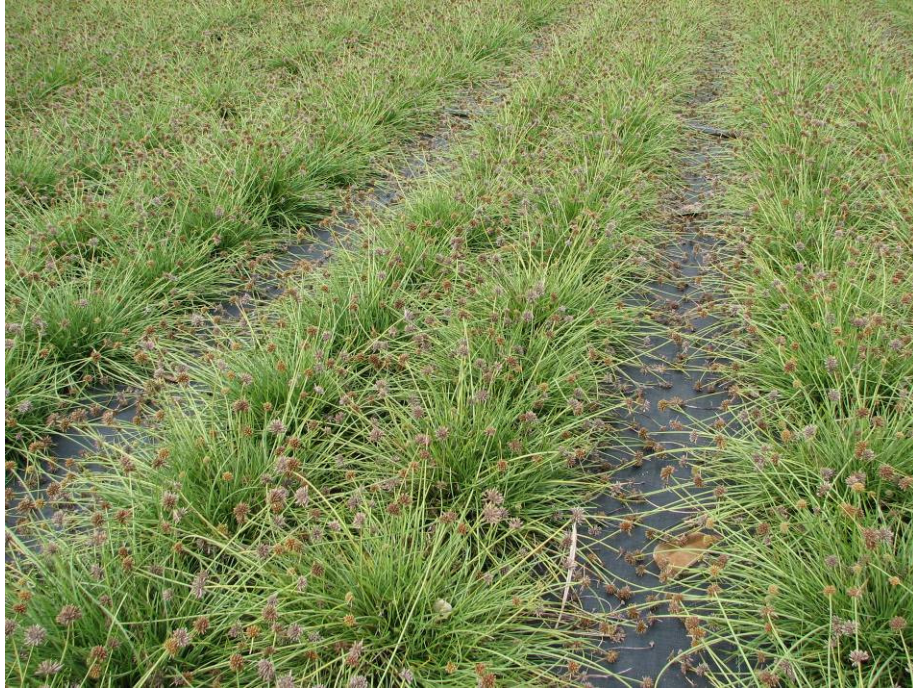
Figure 1.3. *Fimbristylis cymosa* stockplants cultivated at the H1-University off-ramp. This species has sometimes been used as a groundcover for landscaped areas.

*Taxonomy and distribution.* *Fimbristylis cymosa* R. Br. is a tuft growing perennial sedge with short rhizomes and stiff leathery leaves (Figure 1.3). It is an indigenous coastal sedge commonly growing on sandy beaches and rocky outcrops along the coast. In Hawai‘i it is documented in all the main islands except Kaho‘olawe; elsewhere, it is widely distributed across the Pacific basin including Australia, western Malesia (Malay Peninsula, Sumatra, Java, Borneo), Pacific Islands and the Neotropics (Wagner et al., 1999). Two indigenous subspecies are recognized, and both occur nearly throughout the full range of the species (Wagner et al., 1999).

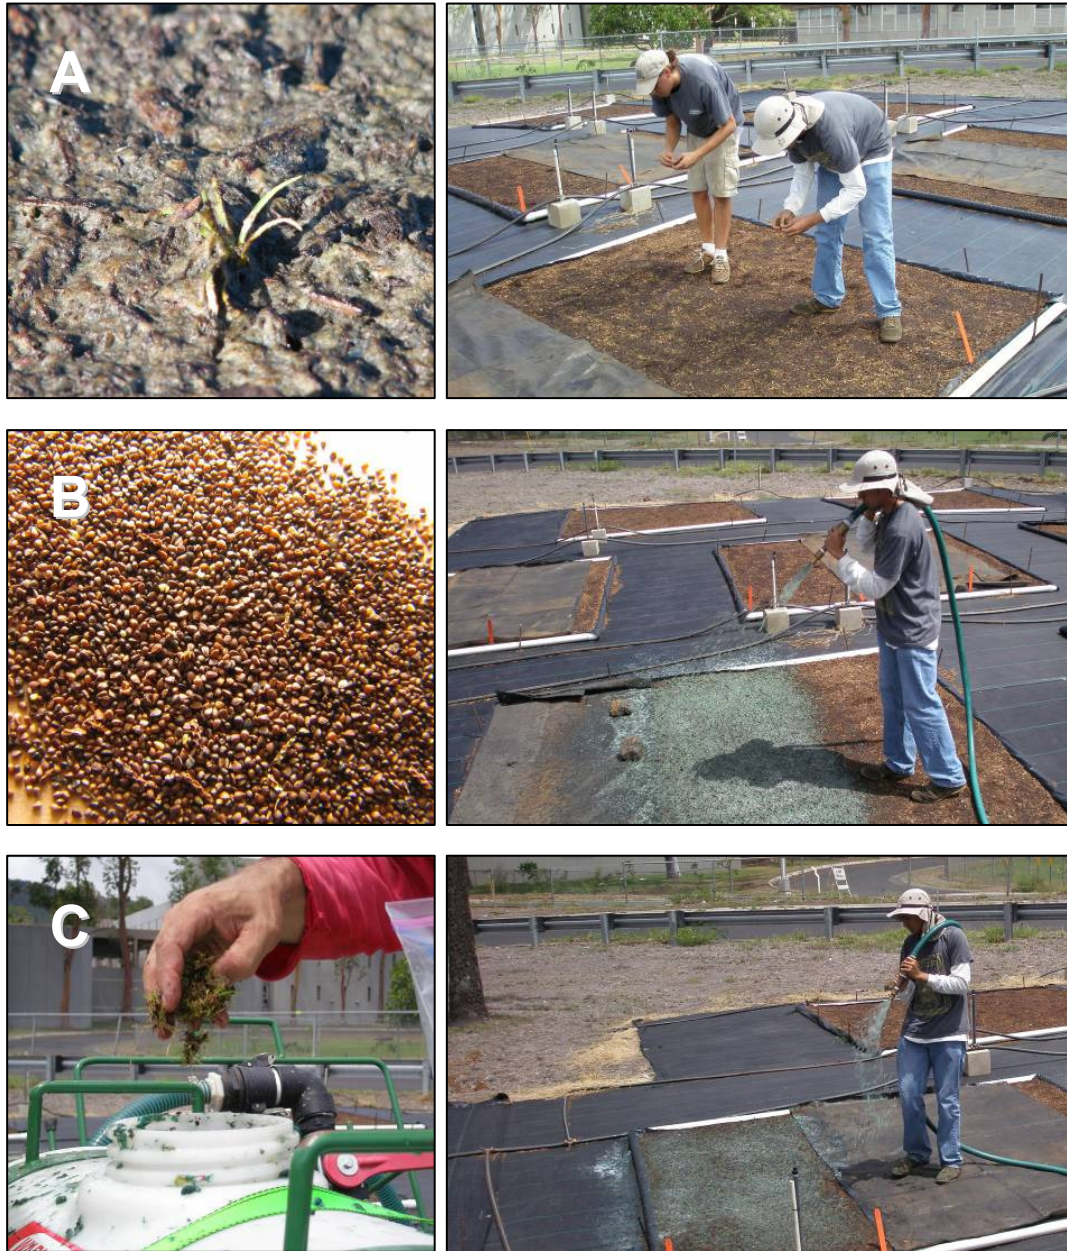
Figure 2.1. The three hydroplanting techniques evaluated in this study: a) handsown seedlings covered with mulch; b) hydroseeding and c) hydroplanted seedlings.

Except for handsown seedlings capped with hydromulch, all materials in each of the two other treatments were mixed together and applied using a hydroseeder. Table 2.1 lists the amount of tackifier (C:tac, Hamilton Manufacturing Inc.), paper mulch (NaturesOwn, Hamilton Manufacturing Inc.) and water used for each treatment. The hydromulch system (Turbo Turf Modular Hydroseeding System Model No. HS-50-M, Turbo Technologies, Inc.) used for applying the treatments consisted of a 190 liter tank and a 5 x 5 cm centrifugal pump applying approximately 114 liters per minute. To reduce contamination of treatments within each plot during the planting operation, areas other than the treatment were covered with weed cloth. Also, the hydroseeding machine was completely flushed with water before the next treatment was prepared. Treatments were randomly allocated within 4 blocks with 1 replicate of each treatment in each block. Each treatment covered 3.1 square meters of experimental area per block.

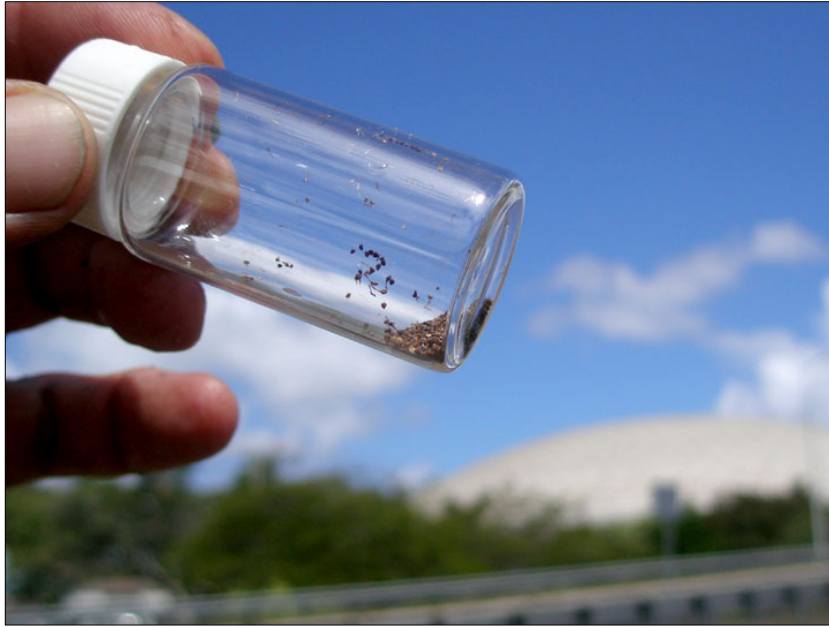
Figure 2.2. The amount of seed used in the hydroseeding treatment. The vial contains 0.1 grams or approximately 1500 seeds.

A day prior to hydromulching, the seedling clumps were separated into individual plantlets by teasing it apart underwater. Individual plants were cleaned and kept moist until ready for use. Approximately 70 grams of plantlets (equivalent to 616 plants) were used in both handsown seedlings capped with hydromulch and hydroplanted seedling treatments. This is equivalent to a sowing rate/planting density of 199 plants/m<sup>2</sup>. For the hydroseeded treatment, 0.1 grams of sedge seed (containing approximately 1,490 seeds) was used to provide a seeding density equivalent to 481 seeds/m<sup>2</sup> (Figure 2.2).

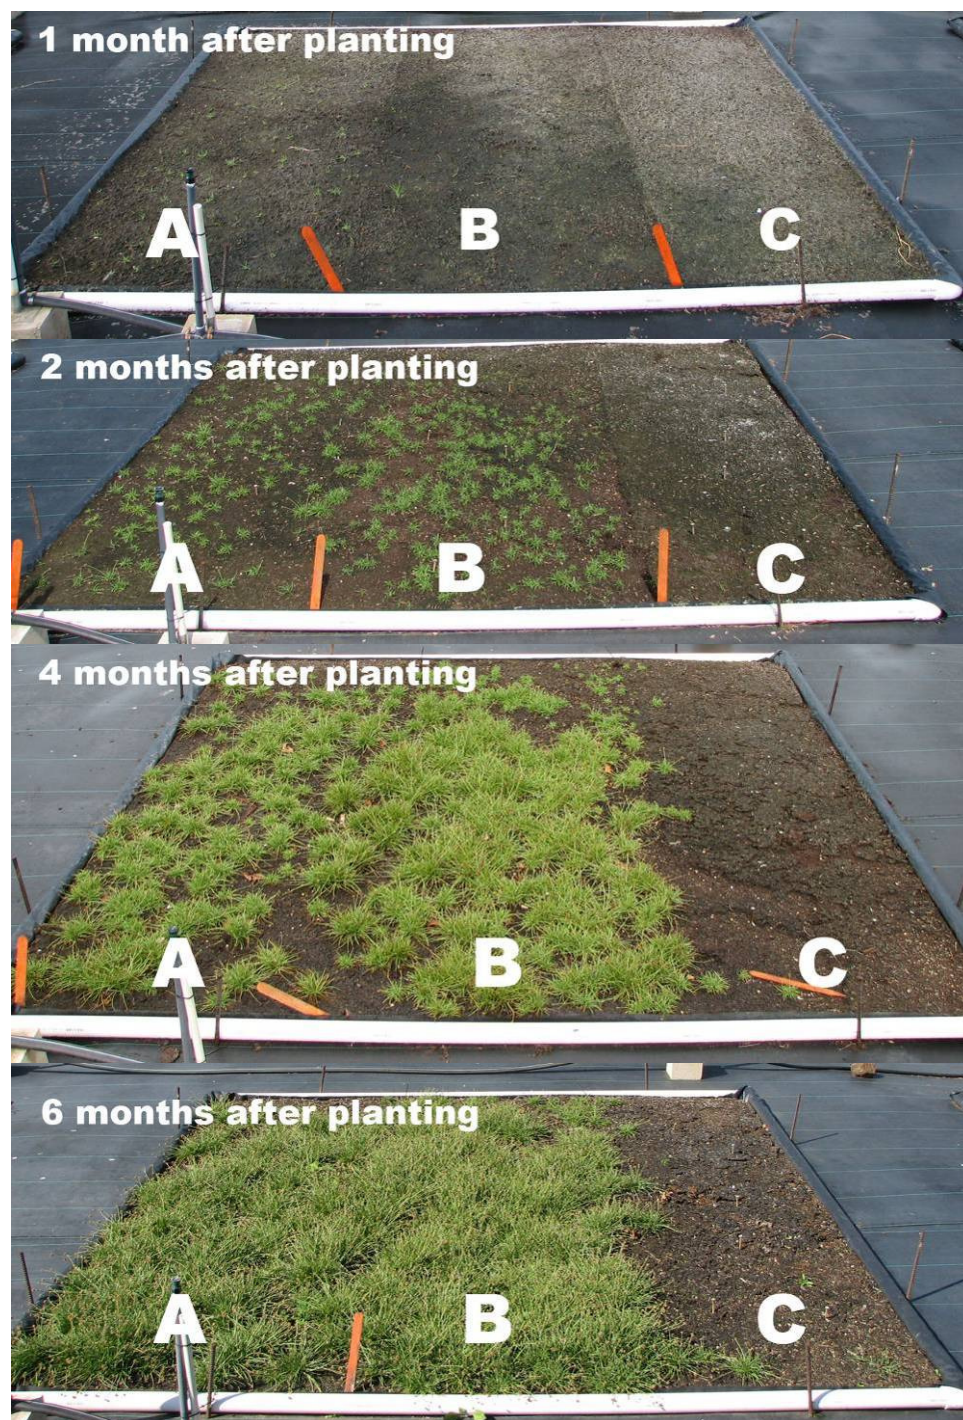
Figure 2.6. Hydroplanting treatments over the period of six months: A) Handsown seedlings covered with hydromulch; B) Hydroseeding; C) Hydroplanted seedlings. Photos were taken at 1, 2, 4 and 6 months after planting.

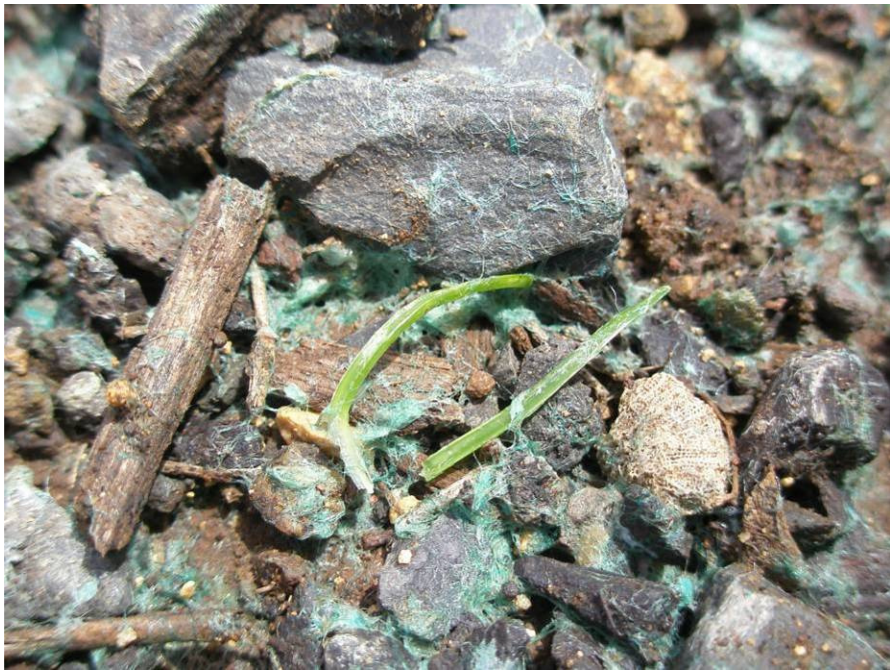
Figure 2.7. Mechanical damage incurred by hydroplanted seedlings during the planting process.

Failure of the hydroplanted seedlings to produce vegetative cover may have been due to severe mechanical damage incurred by seedlings as they passed through the pump. During the hydroplanting process, seedling pieces were often seen being extruded by the hydromulcher (Figure 2.7). The hydromulching equipment used for the experiment is not recommended to deliver larger vegetative pieces such as the seedlings of *F. cymosa*.

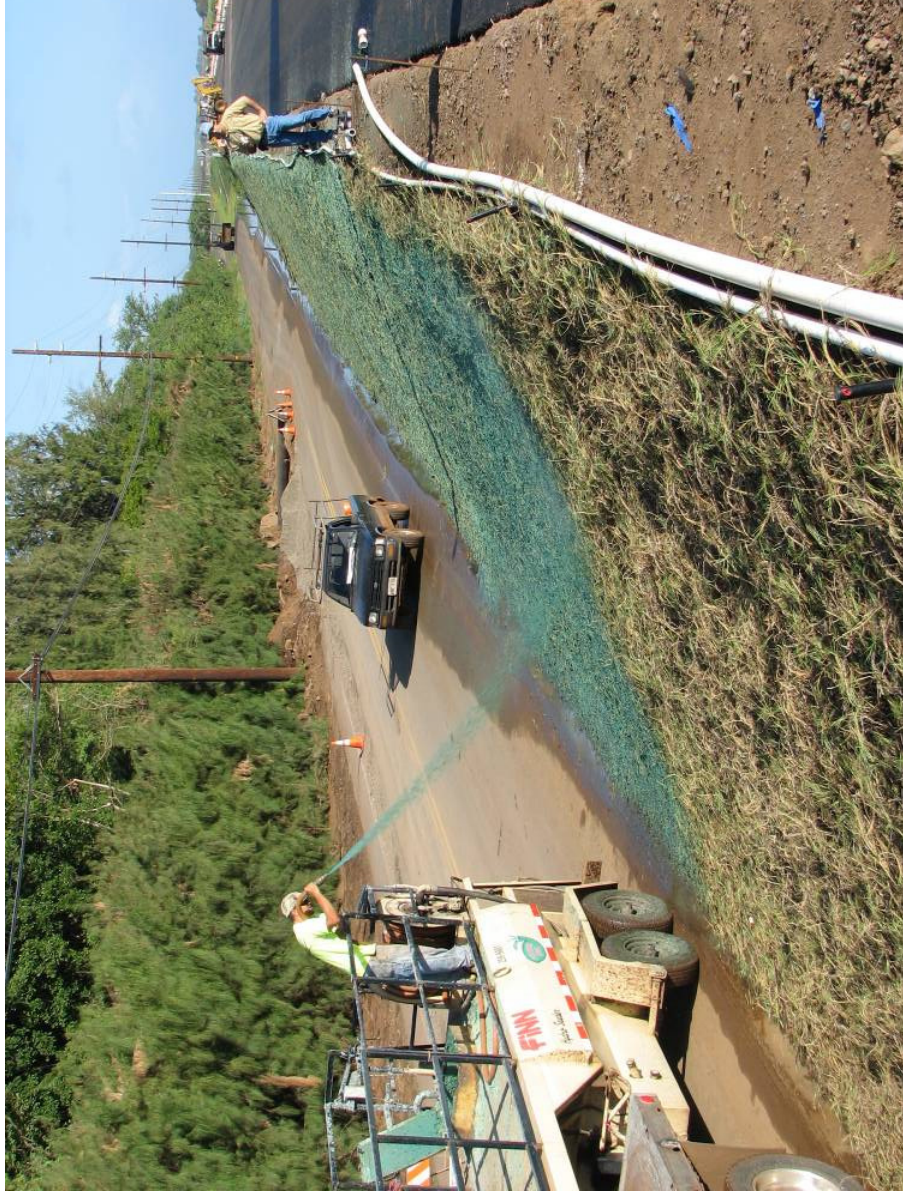
Figure 3.1. Hydromulch capping of untreated *S. virginicus* stem cuttings along the Mokuale Highway near Kihei, Maui (February 2008). Although this method of planting has already been employed in the field, studies on rooting success need to be conducted in order to efficiently utilize planting materials.

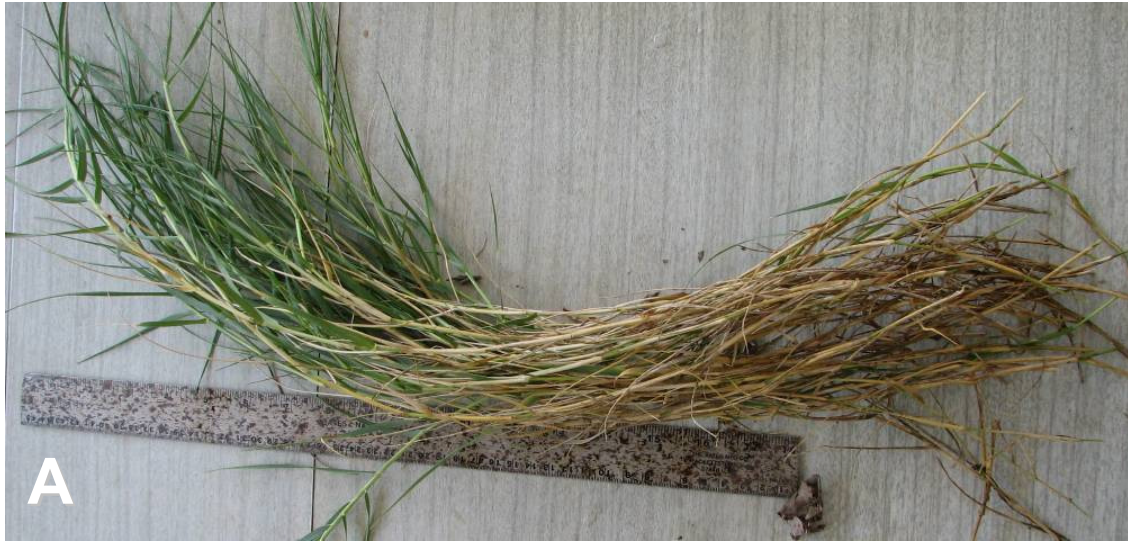
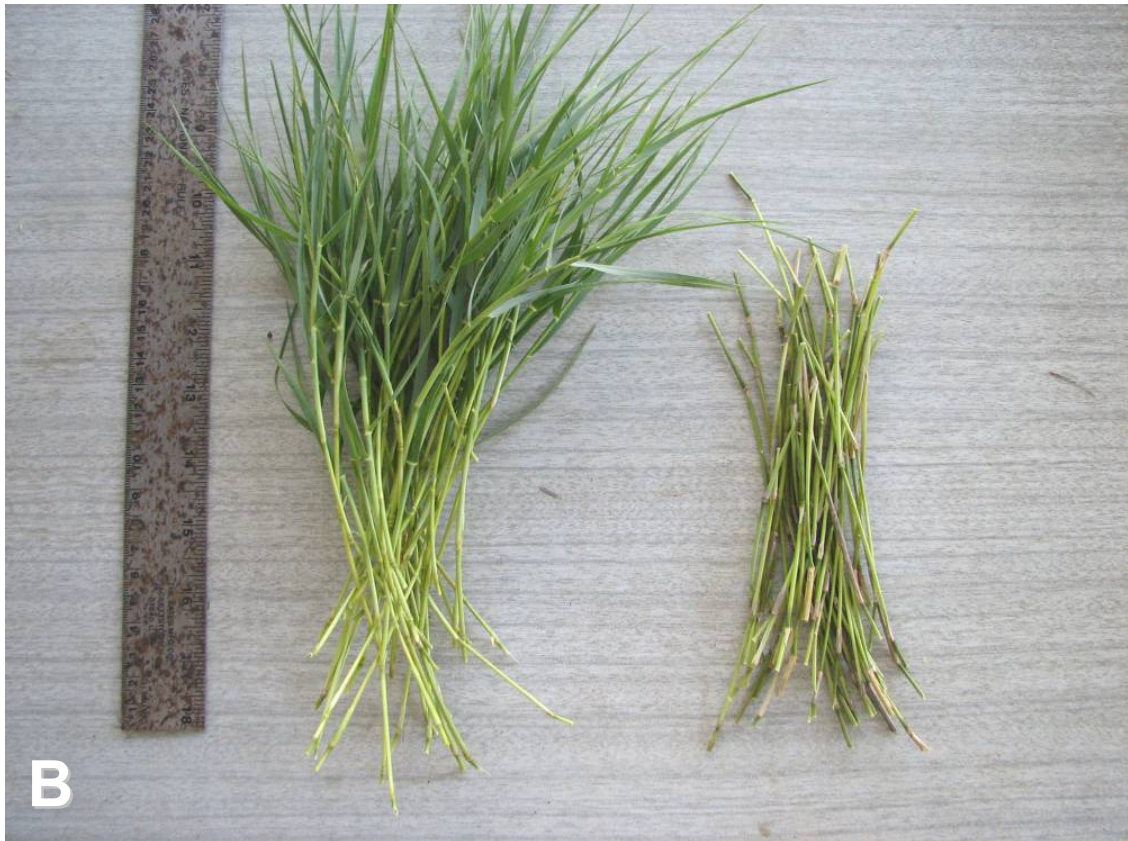
Figure 3.2. Planting material used for the plant part by soaking time experiment. A) Fifty centimeter stem sections from which B) 10 node apical and 3 node basal cuttings were collected.

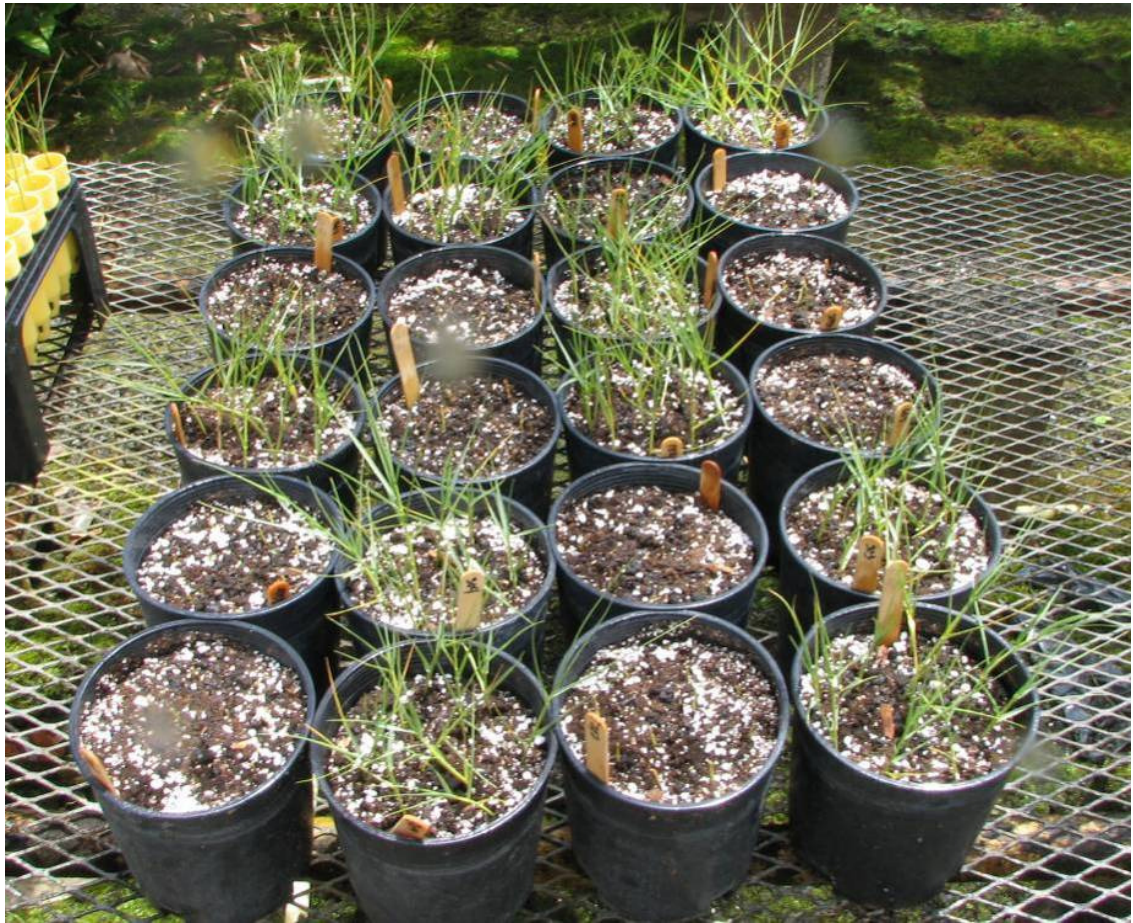
Figure 3.3. Treatment setup in the mist house. Cuttings were left in the mist/shade house for two weeks before transferring to full sun conditions.

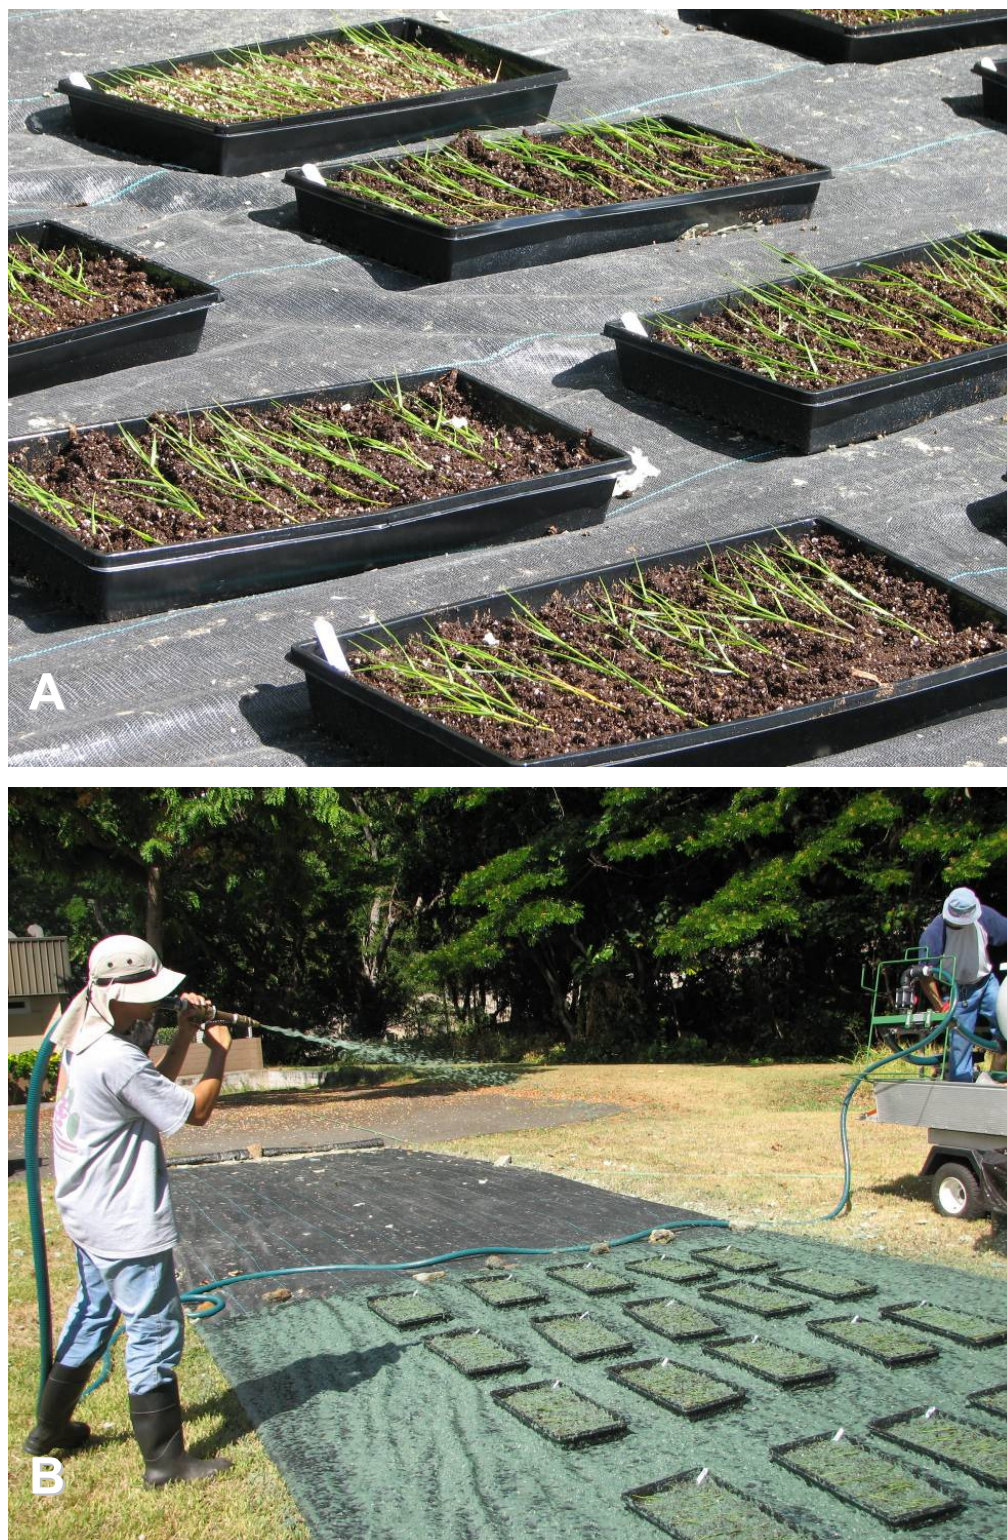
Figure 3.4. The hydromulch capping process for *Sporobolus* apical cuttings. A) Treated and untreated cuttings were laid out horizontally on plastic trays filled with moistened potting mix and then B) covered hydromulch (3300 kg/ha).

For each treatment (replicated 5 times), ten cuttings were laid down horizontally on plastic trays (25.5 x 51.5 cm) filled with moistened potting mix (Pro-mix<sup>®</sup>, Premier Horticulture). The trays with stem cuttings were then transferred to a weed cloth covered area (3.7 m x 4.1 m) and hydromulched at a rate of 3300 kg/ha using a hydromulcher/hydroseeder (Turbo Turf Modular Hydroseeding System Model No. HS-50-M, Turbo Technologies, Inc.) (Figure 3.4). Table 3.1 lists the amount of paper mulch (NaturesOwn, Hamilton Manufacturing Inc.), straw mulch (HydroStraw, HydroStraw LLC) and tackifier (C:tac, Hamilton Manufacturing Inc.) used to make the 95 liter hydromulch mixture.

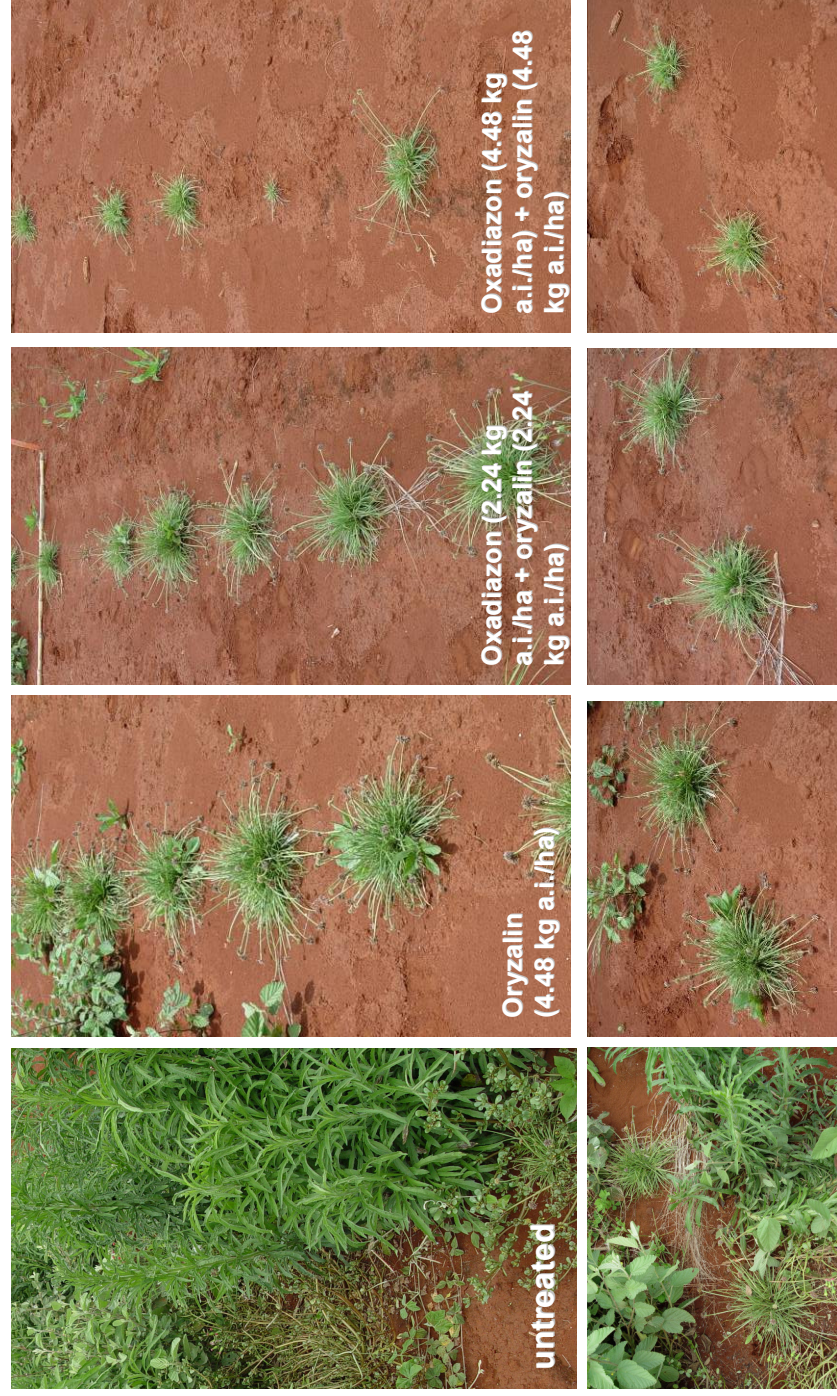
Figure 4.1. Visual comparison of weed control in plots (top) and vigor of representative plants (bottom) after two subsequent applications of pre-emergence herbicides. At 211 DAS, untreated plots (left) were weedy while plots treated with pre-emergence herbicides remained almost weed free. Both the high rate of oxadiazon (3<sup>rd</sup> from the left) and oxadiazon + oryzalin (next page) have noticeably stunted plants in comparison to the other treatments.

Figure 4.1 continued. Visual comparison of weed control in plots (top) and vigor of representative plants (bottom) after two subsequent applications of pre-emergence herbicides.

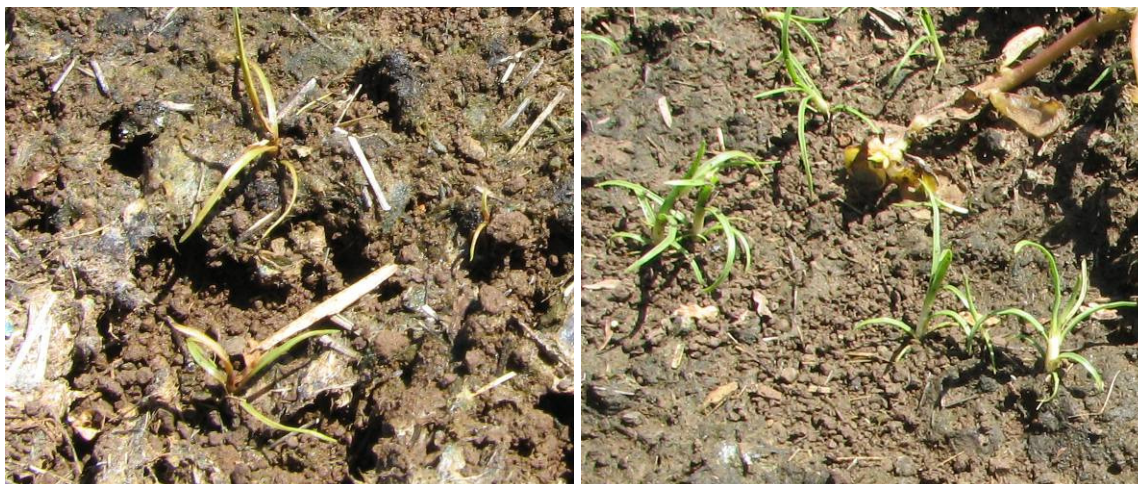
Figure 4.4. A comparison of seedling damage 4 days after post-emergence spray application (0.1 kg a.i./ha aminopyralid + 0.28 kg a.i./ha fluazifop-p-butyl) with (left) or without (right) a wettable powder formulation of oxadiazon. Adding oxadiazon (2.24 kg a.i./ha) in the post-emergence herbicide spray (at 28 DAH) caused severe foliar damage that lead to significantly low plant counts. In contrast, seedlings sprayed with only the post-emergence herbicides (aminopyralid + fluazifop-p-butyl) exhibited slight yellowing and contortion of the leaves (right photo).

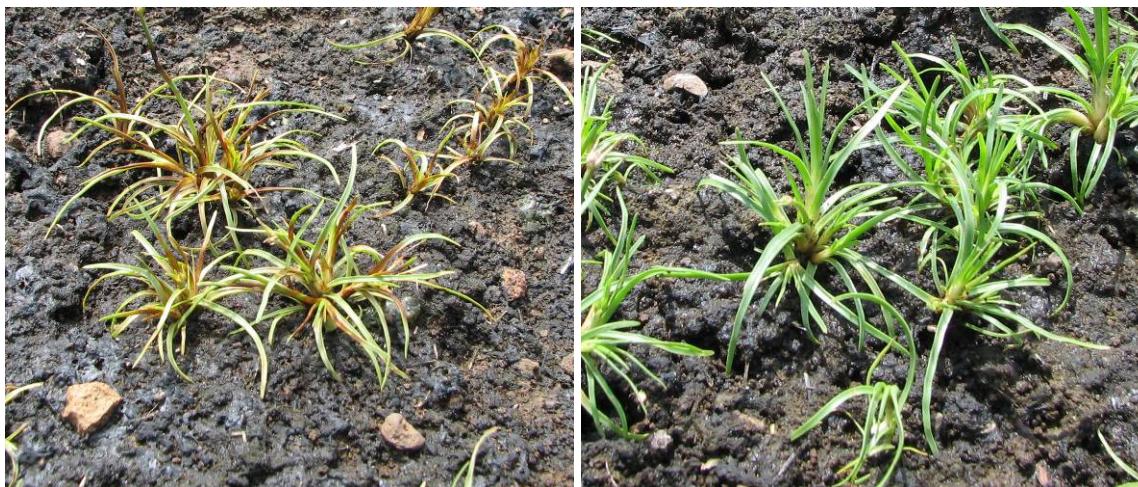
Figure 4.5. A comparison of seedling damage 1 week after post-emergence spray application (0.1 kg a.i./ha aminopyralid + 0.28 kg a.i./ha fluazifop-p-butyl) with (left) or without (right) a broadcast application of granular oxadiazon (2.24 kg a.i./ha). Foliar damage caused by the application of granular oxadiazon (at 42 DAH) was similar to those observed in treatments sprayed with the wettable formulation.

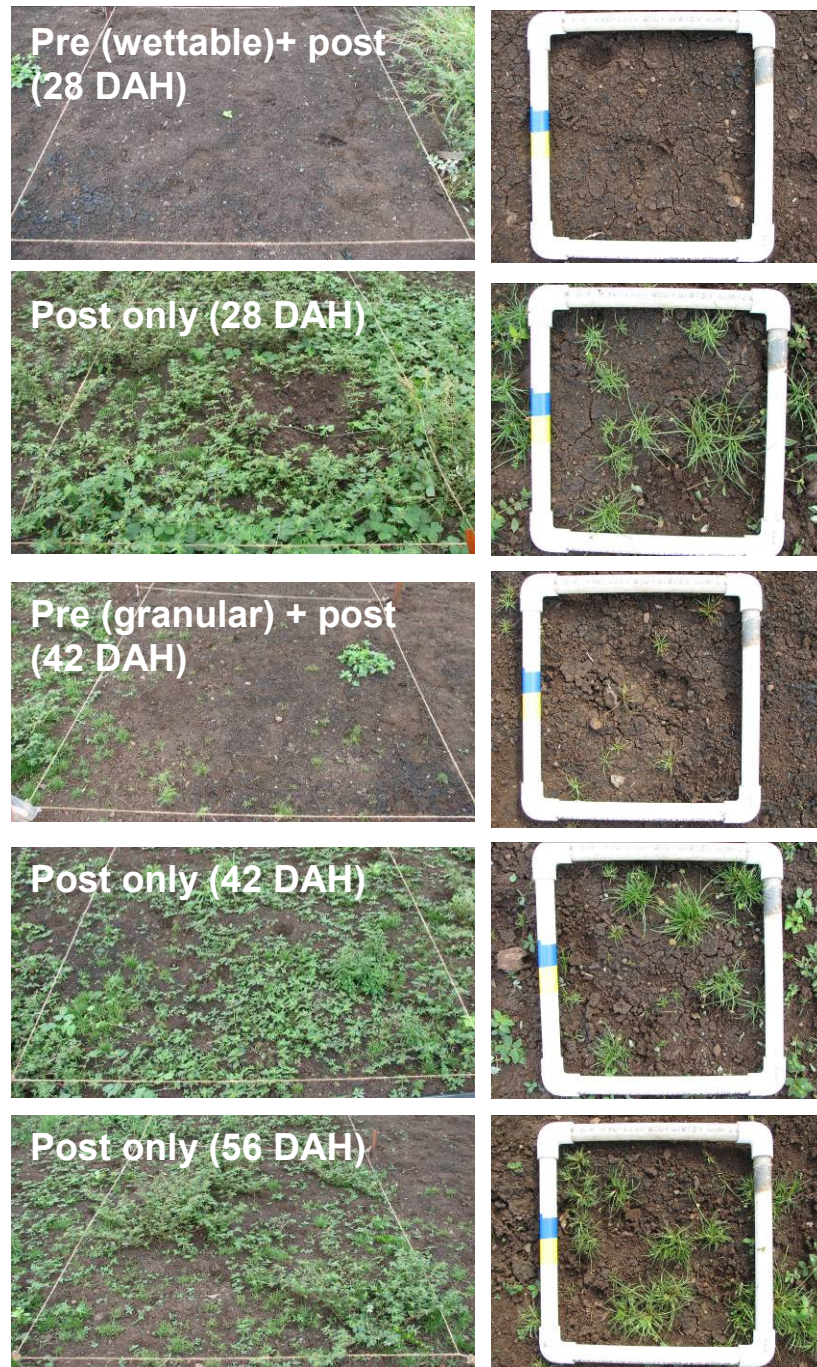
Figure 4.7. Visual comparison of weed control and plant density (0.3 x 0.3 m square) in plots treated at different dates with pre- (2.24 kg a.i./ha oxadiazon, as wetttable or granular formulation) and post-emergence herbicides (0.1 kg a.i./ha aminopyralid + 0.28 kg a.i./ha fluazifop-p-butyl). At 92 DAH, treatments applied with wetttable and granular formulations of oxadiazon (2.24 kg a.i./ha) have noticeably reduced *Fimbristylis* plant density. Invasion of weedy spurge species can also be seen in the post-emergence only treatments.

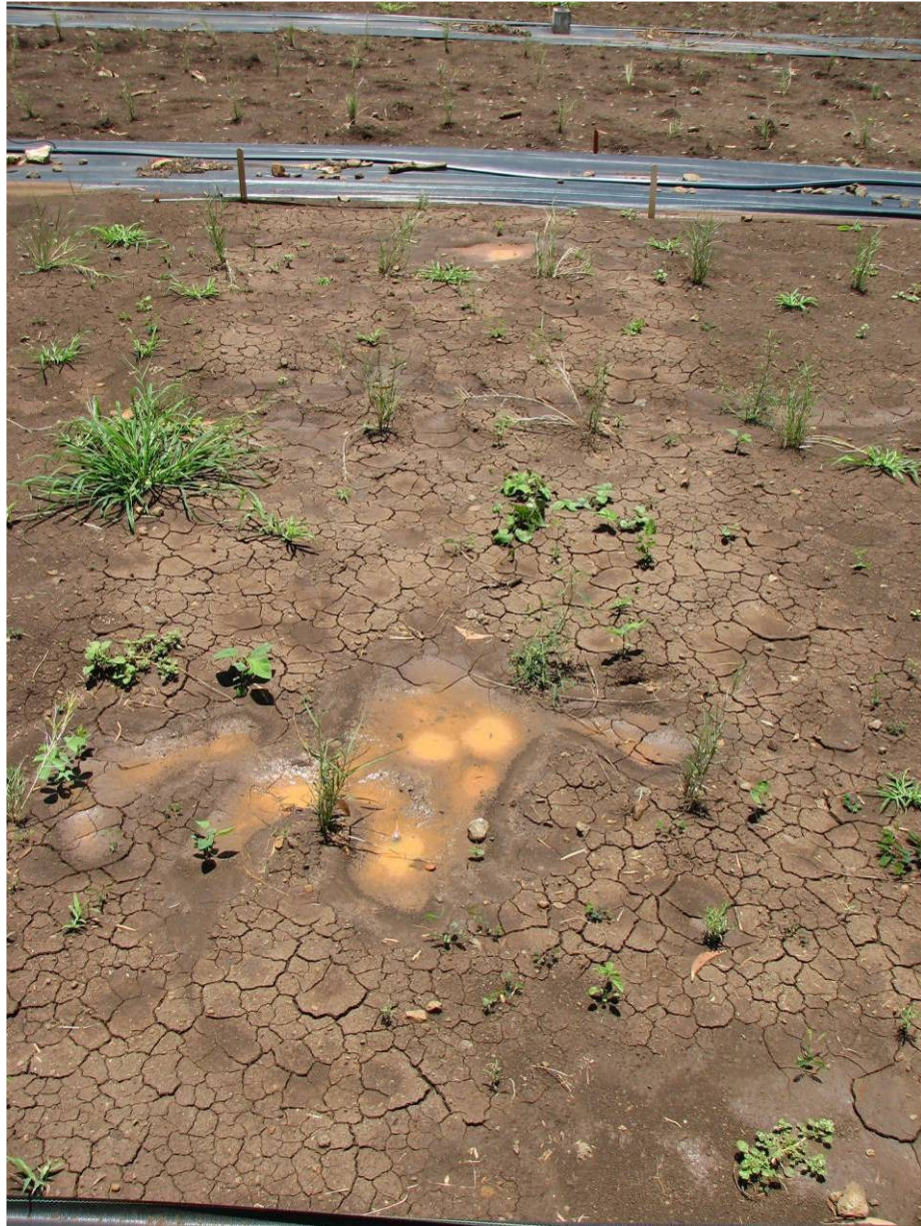
Figure 5.1. Altered surface soil structure of table salt treated plots. Salt application (448 kg a.i./ha) caused the soil to disperse and lose its structure, creating a puddled surface when wet and a cracked surface when dry.
