FIELD TESTING OF WOOD PRESERVATIVES XVIII PERFORMANCE OF BORATE-TREATED WOOD AGAINST SUBTERRANEAN TERMITES

P. I. Morris¹ and J.K. Grace² and K. Tsunoda³

¹ **FPInnovations – Forintek Division, 2665 East Mall, Vancouver, BC V6T 1W5, Canada**

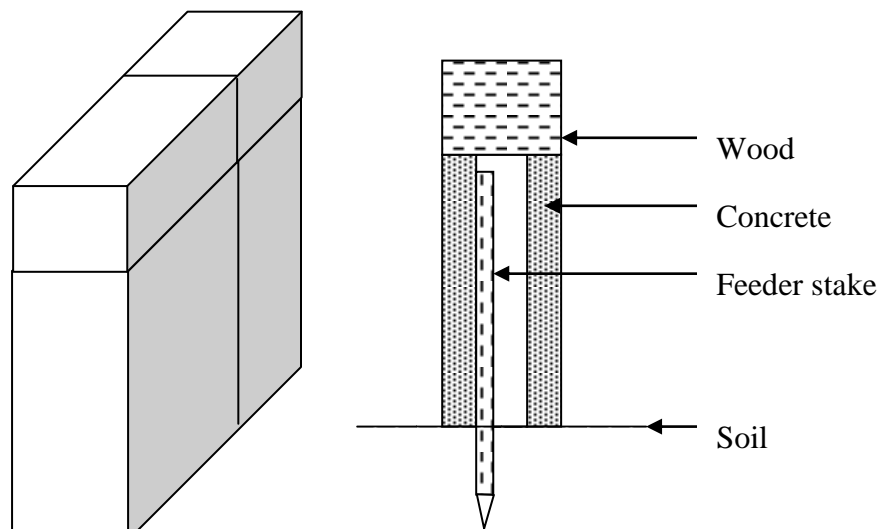
Figure 1 Cross-section of test assembly.

The exposure test method involved laying wood samples on top of hollow concrete blocks standing on the soil surface and then covering the structures with a box to protect them from rain and maintain high humidity. There was no direct contact between the wood samples and the soil, other than that brought by the termites to construct shelter tubes. The covering boxes in Ontario were constructed from CCA-treated plywood. The inside and outside were painted with exterior primer and two coats of white paint to prevent excessive interior build-up of heat in direct sun. In Hawaii, the plywood covers were untreated and were replaced as necessary due to termite damage and weathering. Again the boxes were painted with exterior primer and two coats of white paint. The covering boxes in Japan were made of white plastic. Within each box at six or eight hollow concrete blocks were placed onto levelled soil 50 mm apart.

Through the two perforations in each concrete block, 25 x 25 x 300 mm feeder stakes were hammered into the ground so that the top of the stake was within 2–5 mm of the top of the concrete block (Figure 1) to encourage initial termite attack. The feeder stakes were prepared from moderately durable heartwood so that they would remain free from decay and mould long enough to be discovered by a foraging population of termites. The test samples were situated

one per block such that they covered the holes in the block but were not in direct contact with the feeder stake. This was to prevent direct tunnelling by termites from the untreated wood stakes into the test samples. This is an extremely aggressive test since all aspects contravene the protective measures one would normally take in wood frame construction (Morris 2000). This test method has now been standardised as AWP A E21-06 (American Wood Protection Association 2009).

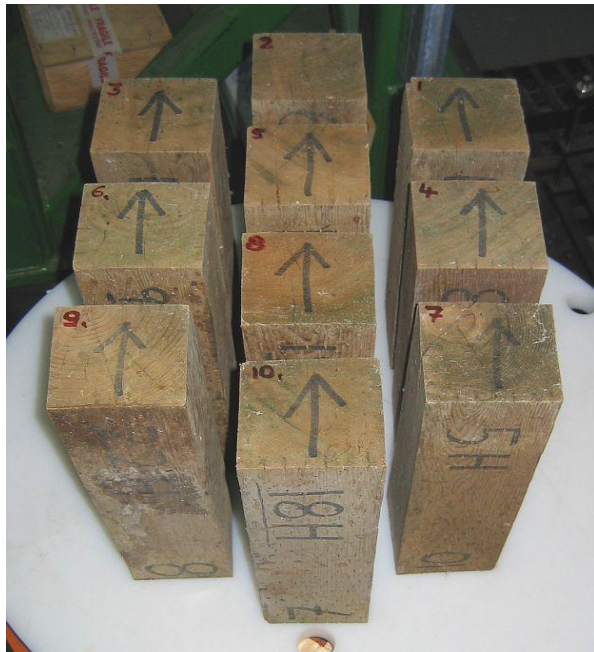
Figure 2 Dodai from Hawaii on CT scanner turntable

Forintek's CT Imaging Centre at the Vancouver laboratory, with a 3.5 MeV industrial x-ray CT scanner, was utilized to examine the samples returned from Hawaii. CT scanning is a nondestructive method for obtaining accurate 2-dimensional images of an object's internal features. The technique uses an x-ray beam that penetrates the object. Transmitted energy is measured by a linear detector array and powerful computers are used to reconstruct 2-dimensional images on a slice-by-slice basis along its length. Slice images can also be assembled to provide a highly accurate 3-dimensional model of the object. During scanning the samples were placed perpendicular to the scanner turntable so the x-ray beam could penetrate through the thickness (Figure 2), and were scanned at 25 mm intervals along the length of the piece.

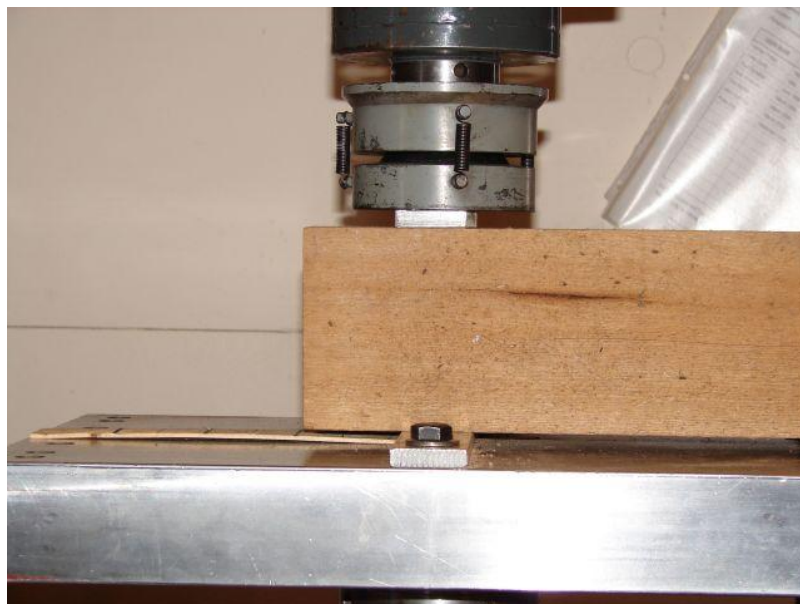
Figure 3 Dodai from Hawaii in strength-testing apparatus

The tests were conducted by the Wood Engineering Group at Forintek's Vancouver laboratory. Each specimen was loaded in compression perpendicular-to-the-grain from a location of 25 mm from one end and at 25 mm increments towards the centre. The specimens sat on a loading plate of 38 mm wide that spanned the width of the specimen. The load was applied through a 38 mm wide plate that spanned the width of the specimen and was mounted on a universal loading head (Figure 4). At each location the specimens were loaded to 2000 pounds at a rate of 0.5 inches/minute. The load and actuator deflection were recorded. The stiffness was calculated by regression analysis of the load and actuator deflection, between 1000 and 2000 pounds. The depth, width and weight of each specimen were also recorded.

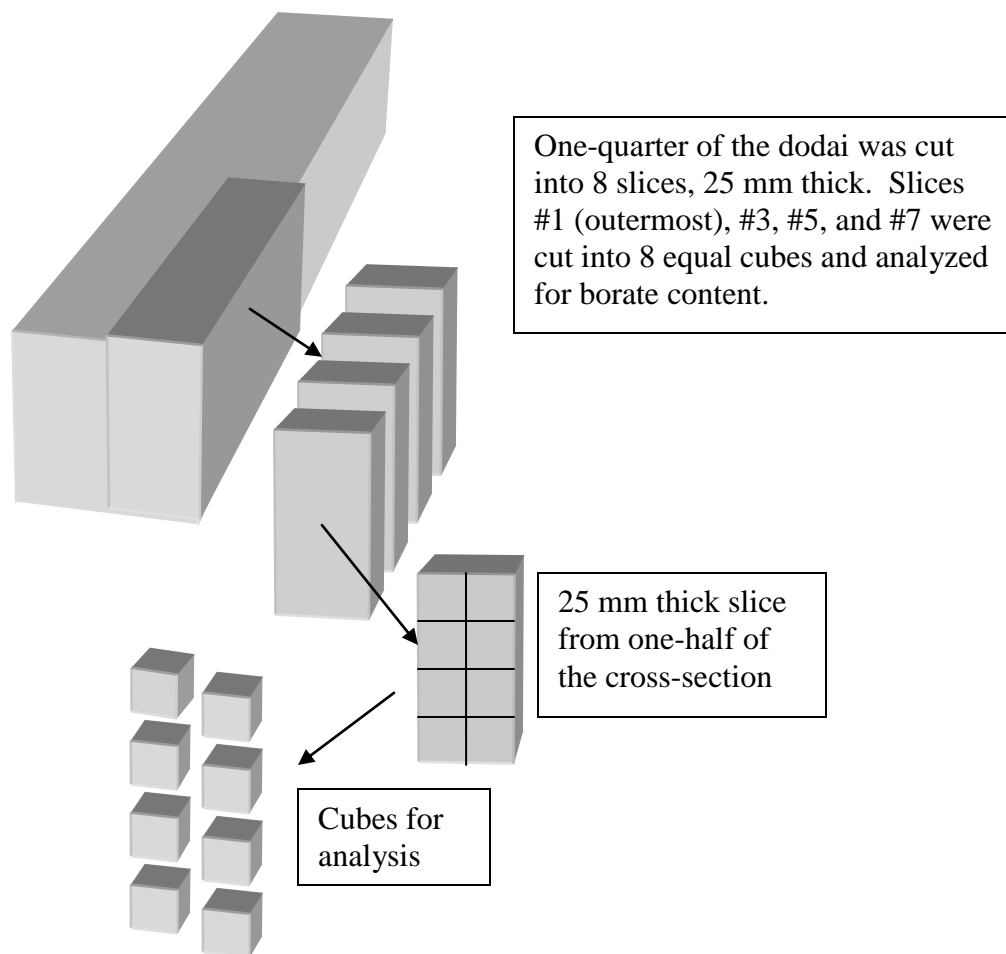
Figure 4 Cutting plan for the dodai

Out of each set of 10 borate-treated replicates from each of the Japan and Hawaii test sites, five samples were chosen randomly for destructive sampling. To minimize the number of analyses, only one quarter of each dodai was sampled (Figure 5). That quarter was sectioned into eight slices, 25 mm thick. Slices #1 (outermost slice), #3, #5, and #7 were further sectioned for analysis into eight equal cubes, each measuring approximately 25 mm³. Slices which had been removed from each dodai prior to exposure and stored at the Forintek laboratory for 10 years were similarly sectioned. Each cube was ground into sawdust for analysis, and the borate was extracted in hot water. Borate retentions were determined by mannitol titration (Winters ca 1965). The equipment used was a Metrohm 702 SM Titrino Autotitrator fitted with a combined pH glass electrode.

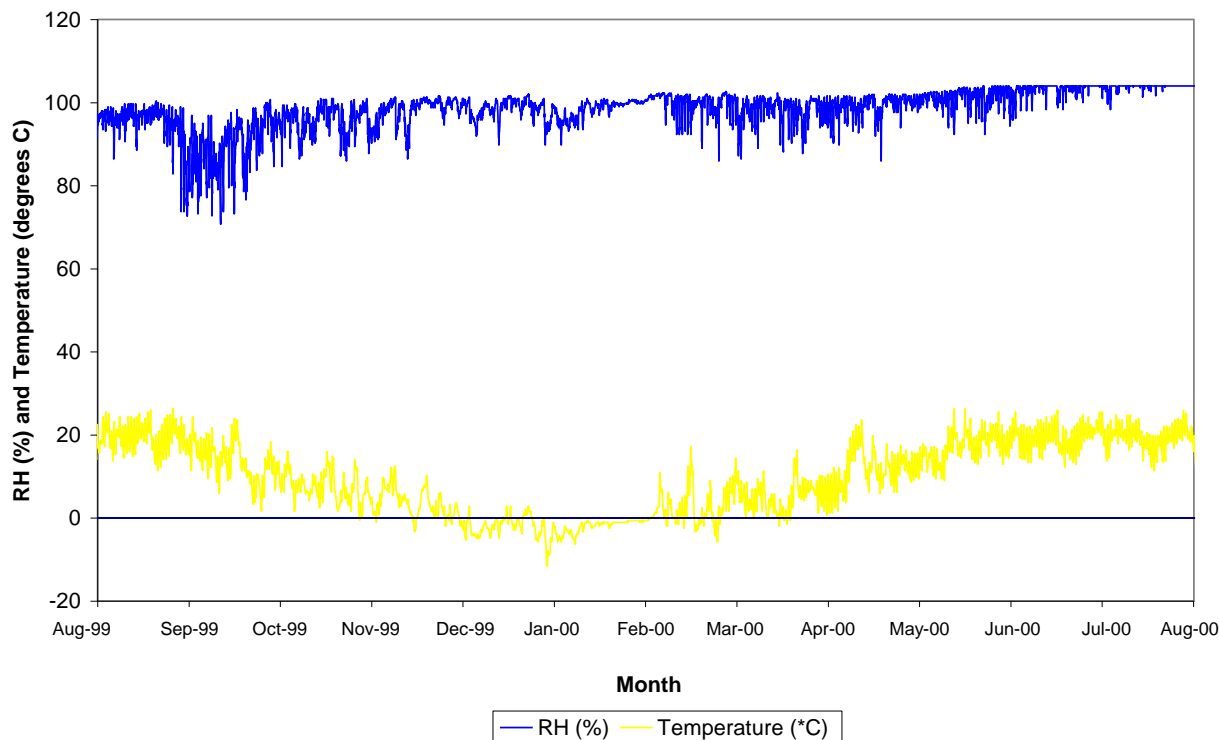
Figure 5 Conditions inside the Kincardine test box during 1999 – 2000

Figure 6 illustrates that the relative humidity inside the boxes at Kincardine remains close to 100% virtually throughout the year, ranging from 75 to 100%, and the temperature ranged from -10°C to 20°C . As a result of such a high humidity, condensation must have formed on the lid of some boxes and could have dripped onto the samples. The tops of samples often appeared wet during inspection. This created a leaching hazard for the borate-treated samples. Similar conditions of high humidity were noted in the boxes at the Hawaii test site.

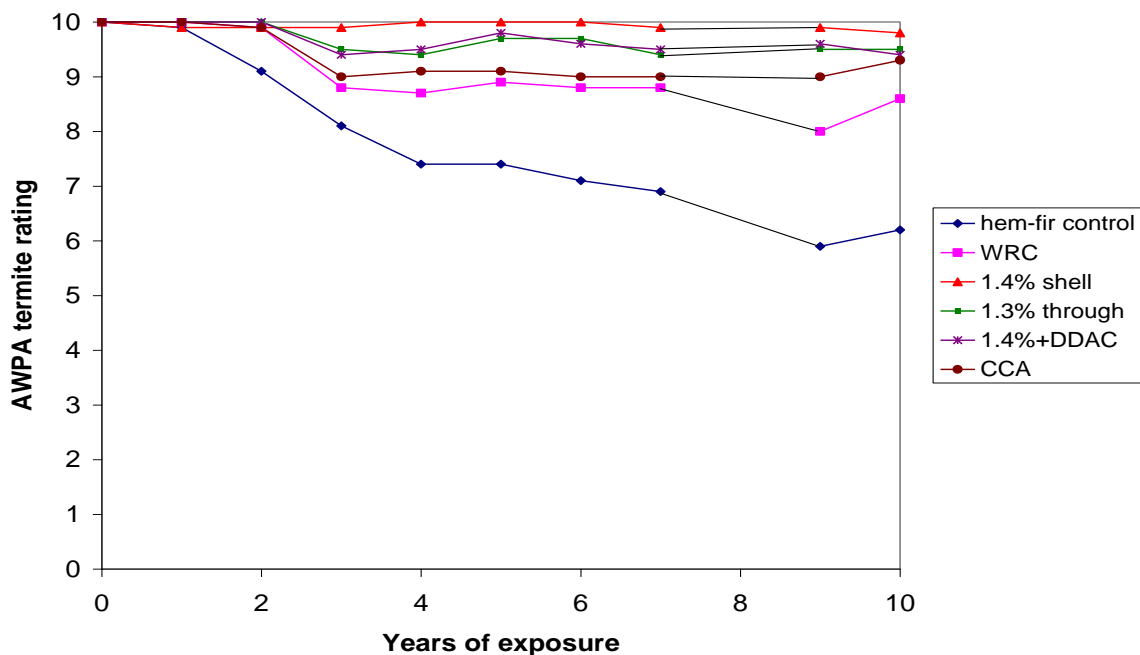
Figure 6 Performance of samples at Kincardine, Canada

At Kincardine no preservative-treated sample received a rating of less than 9 at the 10-year evaluation. Borate treatments performed as well as CCA treatments, with mean ratings of 9.0 or higher. At this stage, there was also no discernible difference between through- and shell-treatments with borate, or from the addition of DDAC. Evaluations at Kincardine between years 2 and 4 overestimated the level of damage to treated material based on exploratory tunnelling that appeared to penetrate the surface, particularly at incisions, on CCA-treated samples. Continued evaluations and probing with stiff wire revealed that these tunnels were shorter than the depth of preservative penetration and did not increase in depth with time. Grace *et al.* (2001) noted that neither DOT nor CCA is repellent to termites, so minor damage is not unexpected.

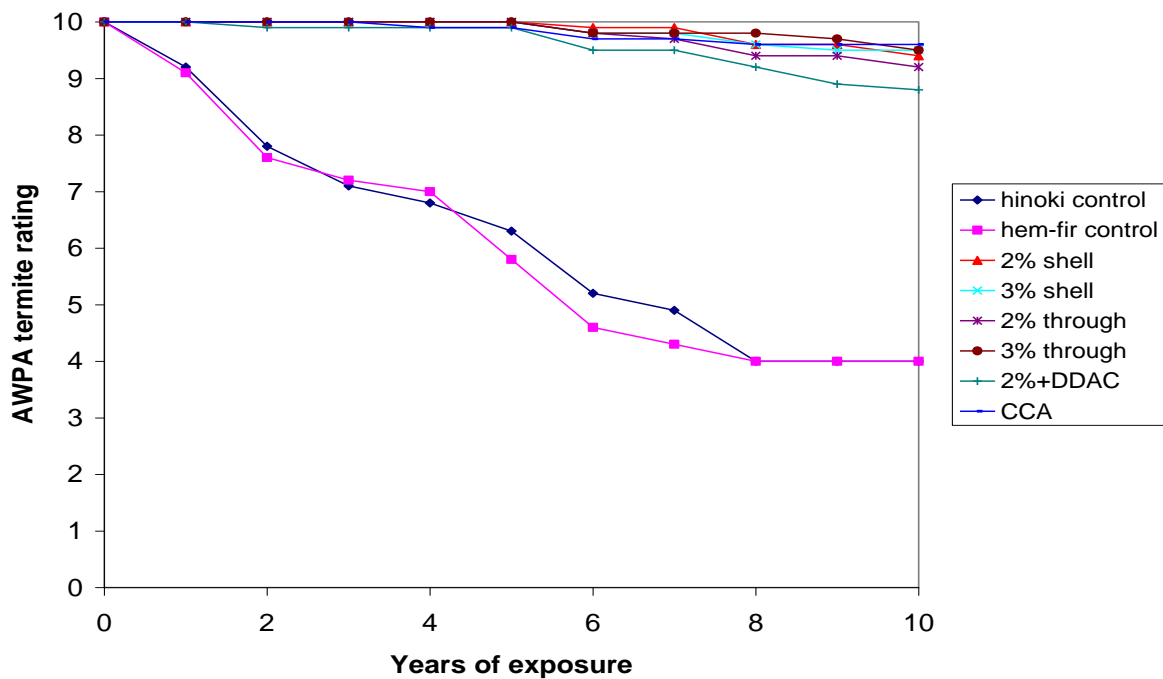
Figure 7 Performance of samples at Kagoshima, Japan

In the parallel test situated at the Wood Research Institute in Kagoshima, Japan, attack of preservative-treated samples was comparable to that found at the Canadian site. This may be partly because the Formosan termite there is close to the northern end of its range. In Japan, samples shell- and through-treated to 2% BAE were rated 9.4 and 9.2. Samples treated to 2%

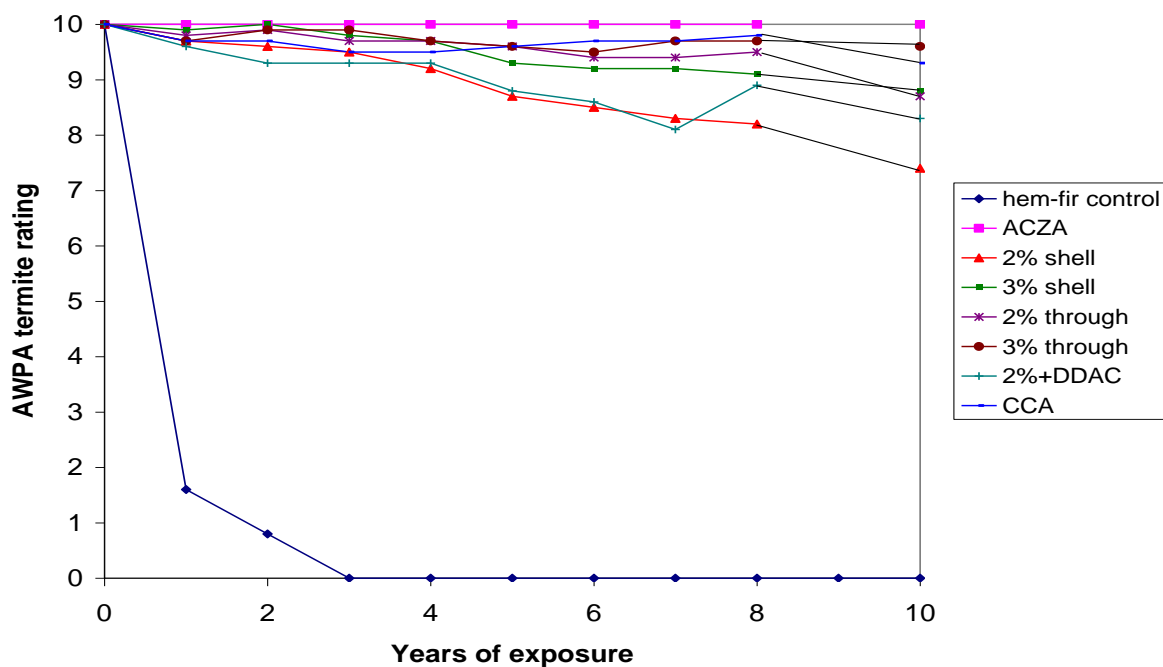
Figure 8 Performance of samples at Waimanalo, Hawaii

In the other parallel test located in Waimanalo, Hawaii, where the climate is highly favourable to termite activity throughout the year, attack was more advanced than at the other two sites. Shell treatments were more severely attacked than through treatments. Mean ratings ranged from 7.4 and 8.8 for the 2% and 3% shell treatment groups, to 8.7 and 9.6 for the 2% and 3% through treatment groups,. All borate treated samples were rated 7 or higher with the exception of one 2% + DDAC shell treated sample rated 4 and one 2% shell treated sample rated zero. There was no significant difference in ratings, based on *t*-tests at the 95% confidence level, between the 2% BAE through, 2% BAE shell, 2% BAE plus DDAC shell/through, and 3% BAE shell treatments. There was also no significant difference in ratings between the 3% BAE through and CCA shell treated hem-fir, which were both significantly higher than the other borate treatments. The ACZA treated Douglas-fir significantly outperformed the other treatments. Although DDAC has not proved to have any additional efficacy against termites in the field tests (Tsunoda *et al.* 1998a; 2000; 2002; 2004; 2006; Grace *et al.* 2000; 2001; 2004; 2006), a three-week lab test on borate with and without DDAC treatment showed a small amount of DDAC substantially reduced weight loss of borate-treated wood (Tsunoda *et al.* 1998a).

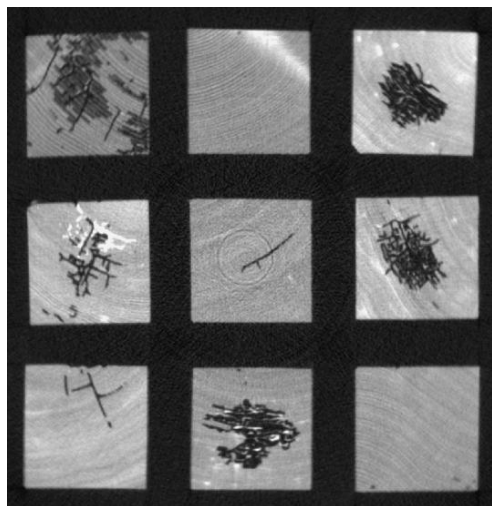
Figure 9 Cross sections of 2% borate shell - treated dodai

Representative images of cross-sections taken half-way along the length of the piece are shown for each borate treatment group returned from Hawaii, as well as for the CCA-treated samples (Figures 9–14). Dark areas in the images represent a lower density area, indicating a void.

The CT scans generally confirmed the field visual ratings, however some internal damage was revealed by the CT scans that could not be detected by an external examination of the samples. In particular, internal voids were seen in three CCA-treated pieces (Figure 14). These had been rated 7, 9, and 9 in the field. The 3% borate through-treatment was the only group with no internal damage (Figure 12) but the 2% borate through treatment had negligible attack.

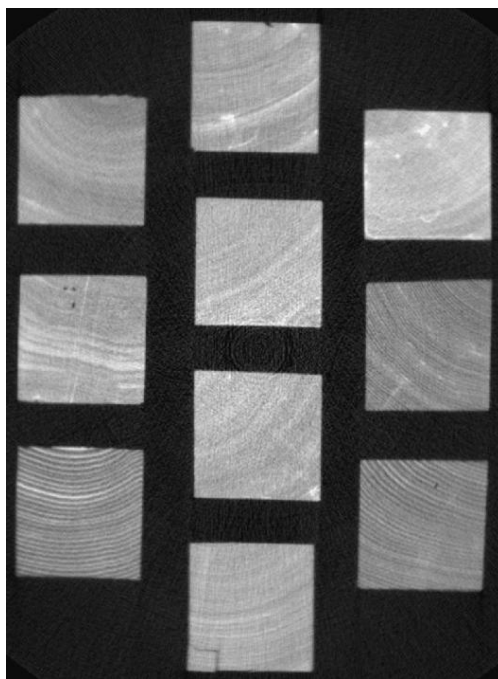
Figure 12 Cross sections of 3% borate through -treated dodai

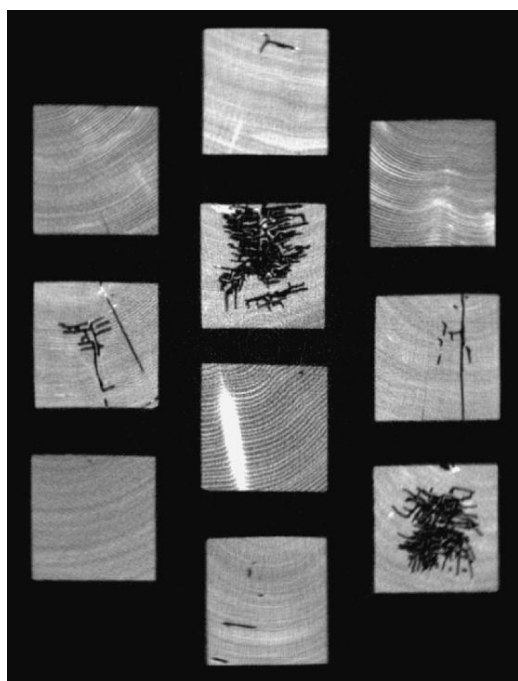
Figure 13 2% borate + DDAC shell/through - treated dodai. The shell treated samples are those with the most damage left/centre, middle/top 2 and right/bottom two. Through

treated samples have negligible or no damage.

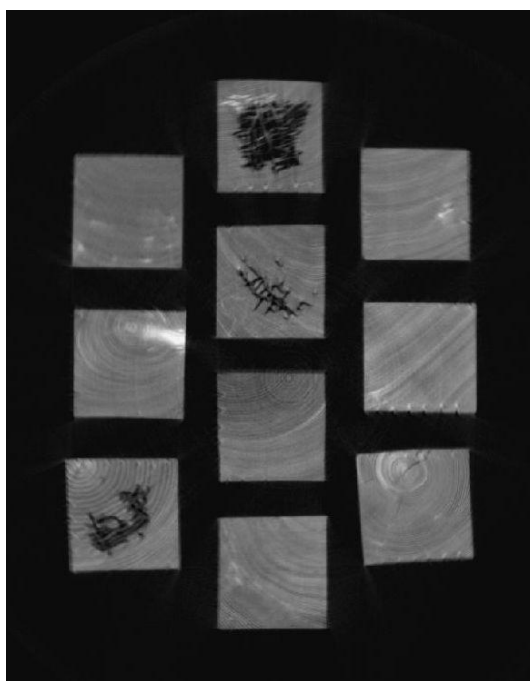
Figure 14 Cross sections of CCA shell - treated dodai.

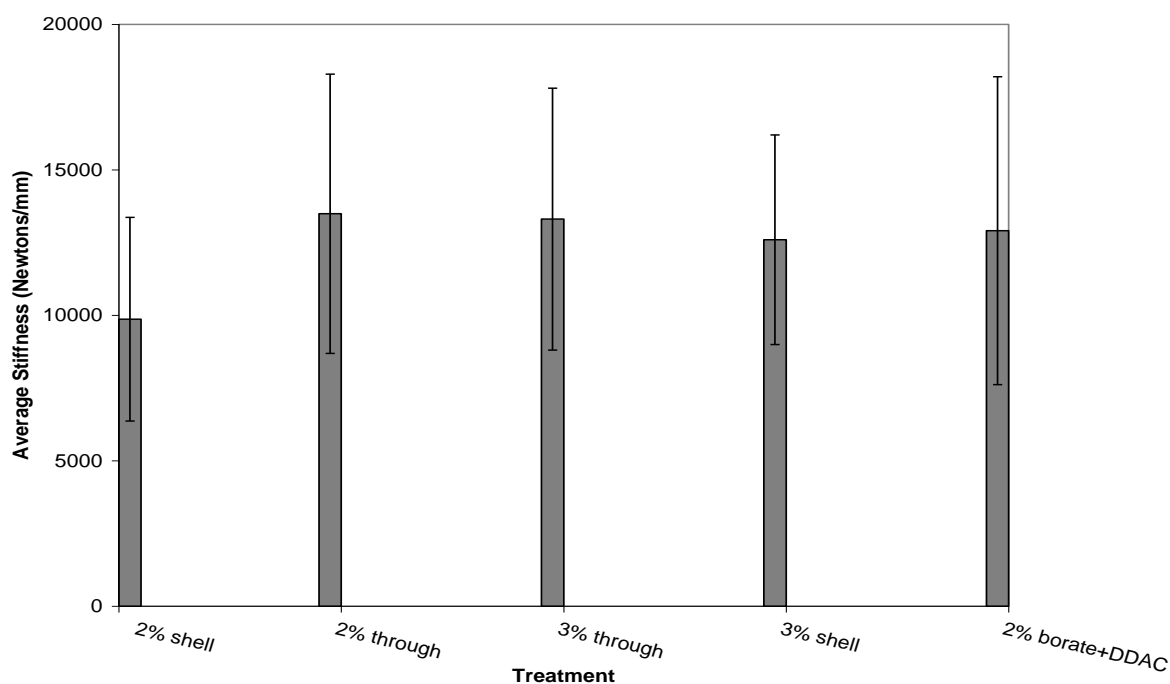
The average stiffness for each borate treatment group was comparable, with the exception of the 2% shell treatments (Figure 15). For any given specimen, the stiffness of any specimen was similar along its length. CT scans of the dodai showed substantial voids in all groups except the 3% through-treated samples. While there was no comparable strength testing done before exposure, the undamaged 3% through treated samples provide a useful reference against which to compare the stiffness of the groups that did have internal damage. Only the 2% shell treated samples showed statistically different stiffness from the 3% through-treated samples, based on *t*-tests at the 95% confidence level.

Figure 15 Average compressive stiffness of each treatment group

Compression stiffness was similar along the length of the dodai. Only the 2% shell treated samples showed statistically significantly lower stiffness than the 3% through-treated samples which had no internal damage.
